# Journal of Engineering Research and Reports

# Evaluation of Surface Water Contamination by Leachate from Uncontrolled Landfills: A Case Study of Yenagoa Central Waste Dump, Nigeria

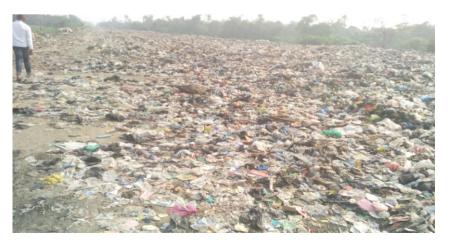
Fig. 1. An image showing a pictorial view of the waste dump

The landfill is specifically located off Edepie-Amassoma road, Etelebu in Yenagoa Local Government Area of Bayelsa State, and operated by Bayelsa State Environmental Sanitation Authority. As at the time of this study, the site which began operations from around 2008 had an average life span of about 11 years. The landfill also had a height of about 2m and covers a total area of about thirty-six kilometers square (36km²). The hydrogeological condition of the landfill site was consistent with the regional hydrogeological setting of Port-Harcourt area as depicted by [13]. A pictorial view of the landfill is presented in Fig. 1.

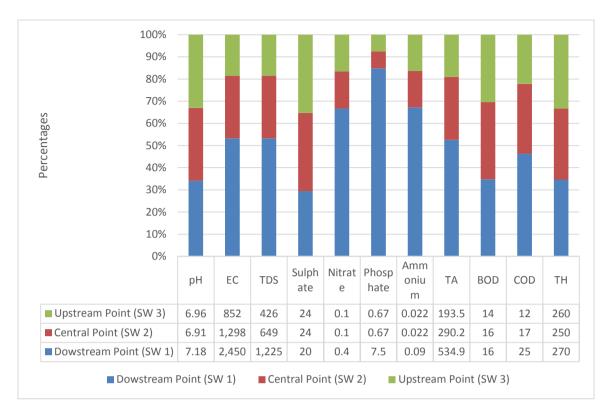
Fig. 2. Percentage composition of surface water parameters within the sampling points

Figs. 2 and 3 showed the percentages of the Physico-chemical and microbial characteristics of the surface water samples analyzed during the sampling period.

All the sampled parameters showed variations across the sampling points. It was observed from the chart above that the values for pH of the surface water samples ranged from 6.96 - 7.18, but were within the WHO recommended range. The EC which ranged from 852 - 2450 uS/cm and Total Dissolved Solid (TDS) with range from 426 - 125mg/l showed similar trends. They both had higher percentages of values that were greater than the regulatory standards at the Downstream (SW 1) and the Central point (SW 2). Concentration of Sulphate (SO<sub>4</sub><sup>2</sup>), Nitrate (NO<sub>3</sub>), Phosphate (PO<sub>4</sub><sup>3</sup>) and Ammonium (NH<sub>4</sub>) also showed similar patterns. They all had the same concentrations at the Upstream point (SW 3) and Central point (SW 2), however, the values at the Downstream point (SW 1) were higher. When compared with NSDWQ and WHO standards, they fell within permissible limits except phosphate. Total Alkalinity, BOD, COD and Total Hardness values ranged between 193.5 - 534.9mg/l, 14 - 16mg/l, 12 - 25mg/l and 250 - 270mg/l respectively. When compared with the regulatory standards, it was observed that they were all above WHO standards except for the TA value at the Upstream point (SW 3). The higher BOD<sub>5</sub> and COD values indicate the presence of organic matter in water [4].
