Asian Journal of Geological Research

Volume 6, Issue 1, Page 1-11, 2023; Article no.AJOGER.97486

# Impact of Municipal Dumpsite on Neighbouring Boreholes in Igbogo Community of Rivers State, Nigeria

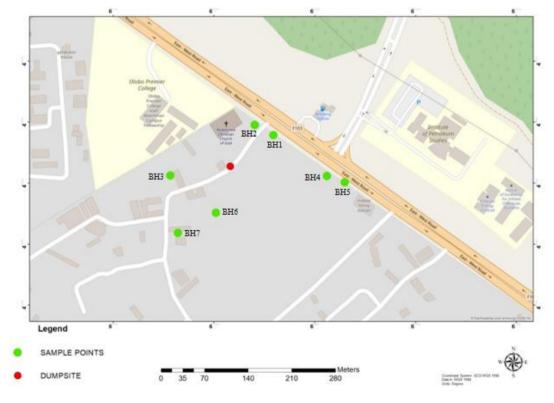
Fig. 1. Map of Igbogo Road dumpsite showing sample points

Groundwater samples were obtained from existing surrounding boreholes close to and far away from the dumpsite. The samples were taken north, south, east and west of the dumpsite. A total of seven borehole water samples were collected. Plastic containers of 200ml were used to collect the groundwater samples. Before the collection of the samples, the containers were washed with acid water in order to sterilize them, and thereafter thoroughly rinsed with distilled water. The collected samples were tightly closed and well labelled. The samples were preserved at 4°C and thereafter taken to the laboratory for analysis. Table 1 presents the coordinates of the borehole water sampling points.

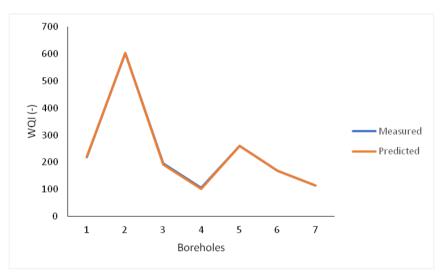
Fig. 2. Measured and predicted WQI

Table 7 shows the measured and predicted WQI values which were later plotted against boreholes to check if the predicted WQI will give a good fit to the measured WQI (Fig. 2). The observed overlap between the measured and predicted WQI in Fig. 2 shows that the developed model has an excellent fit to the measured data.
